# Viceroy Mk IV

KW Electronics Ltd.

Notes by Gwyn Griffiths, G3ZIL

## Restoring a KW Viceroy Mk IV HF single sideband transmitter

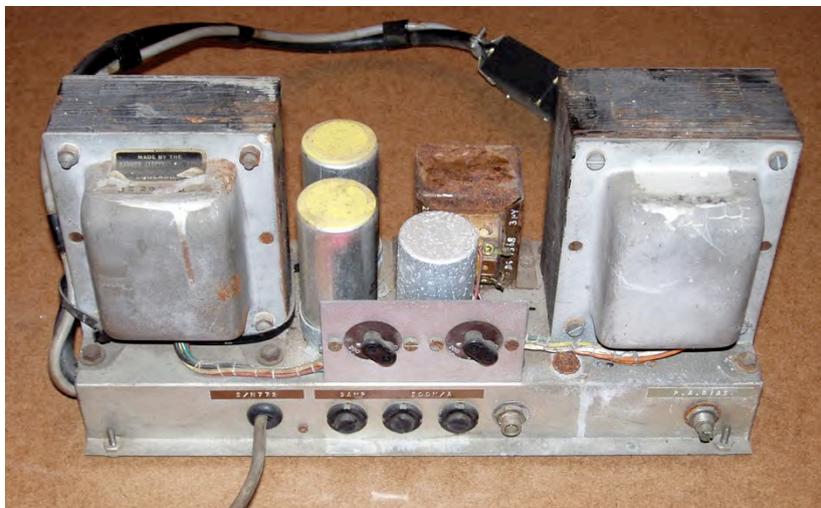
Figure 1. Power supply unit removed from the case, in as received state, having brushed off the worst of the rust on the transformers and the smoothing choke, rear centre.

The power supply was in fair condition, with no extensive corrosion, Figure 1. Given the simplicity of the wiring, and what I felt was the definite need to replace the high voltage capacitors, it was completely stripped down. This was, of course, after a circuit diagram had been drawn, as an exact correspondence with published circuits was not possible. For example, single diodes, not multiple, were used in each arm of the 750V supply. Careful notes were made of the transformer wiring colours.

Dismantling started with the “750V” tag strip, followed by the associated capacitors from their clips, the mains voltage selector panel, the “750V”

transformer, mains cable and its tag strip, and then the three fuseholders. The rusted smoothing choke for the “350V” supply was removed, measuring 3H inductance and 75 $\Omega$  resistance, marked with a 200mA maximum current. The details would be inscribed on the cleaned and repainted shroud. The “750V” transformer was dismantled, noting that green connected to the 200V tag on the voltage selector panel; yellow to 220V and red to 240V. The loose rust was cleaned off with a file and carbide paper. There followed treatment with Kurust rust converter from Hammerite, before spray painting with a grey aluminium primer, which mimicked the original finish. A silver paint was used on the metal clamp of the choke.

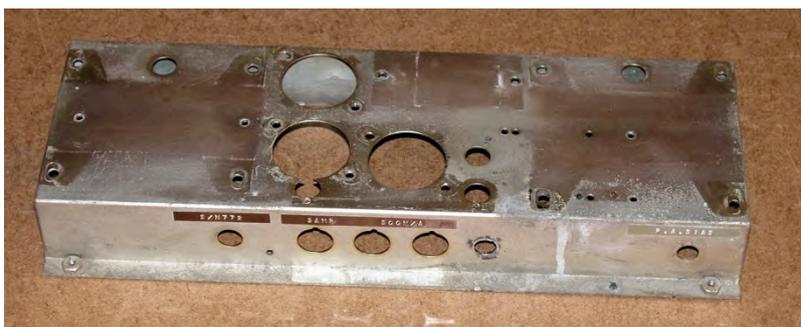
Figure 2. Power supply chassis stripped down completely, before bead-blasting.

With all components removed, Figure 2, the chassis was bead-blasted clean. A near original finish was achieved. All of the mounting hardware, the nuts, bolts, set-screws, voltage selector panel etc. were cleaned in an ultrasonic bath. Those that were rusty were first soaked in a citric acid-based cleaner (Hammerite Rust Remover Dip), and a dilute solution was used in the ultrasonic bath for a final clean.

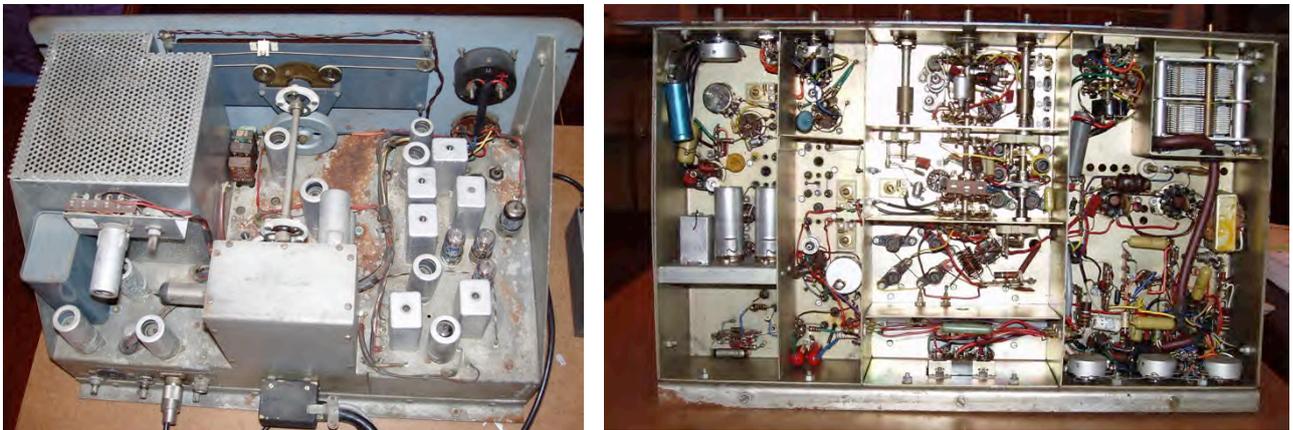
The upper surface of the transmitter was in rather poor shape (Figure 4 left). There were extensive rusty patches, and evidence of pitting in those areas. There was clear evidence that mice had been active on the upper chassis! This Viceroy transmitter unit comprises three chassis sections, in addition to the power supply: the single sideband generator unit; the VFO, oscillators and mixer to generate multiband signals and the PA, VOX and aerial change-over. Of the three sections on the upper side of the chassis, the PA was least affected, the VFO, oscillators and mixer being the worst. In contrast, the underside was in rather good condition throughout (Figure 4b). From the condition of the underside I felt there was no need to dismantle completely, as was done for the (simpler!) power supply,

*Figure 4. Left: As received, upper chassis, showing extensive corrosion of the plated steel especially on the centre section. Right: in contrast, the underside was in good condition, and did not need a rebuild.*

but would proceed to separate the three chassis sections, disconnect their interconnections, and clean, treat and paint the upper surfaces.

The cleaning method employed was first, use a small brass wire brush with the inlet of the garage vacuum cleaner held close and a dust mask worn, second, emery paper, again with vacuum and dust mask, and then a gel Hammerite Rust Remover, applied with a small stiff brush or cotton buds. This was left in contact for an hour or so, and then cleaned off with clean water. The worse patches needed a second treatment. A Humbrol silver enamel paint was then used in several coats with fine emery between coats to help smooth out the pitting.

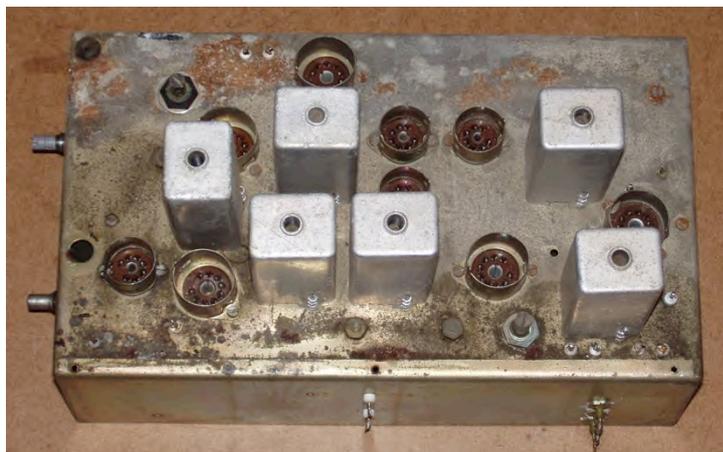
*Figure 5. The sideband generator chassis, disconnected and ready for cleaning.*

First, a sketch of the layout of the upper surface of the chassis was made, showing the valve locations, the locations of the crystals, and the wire colours to each of the connection posts, on the upper surface, and the six on the side of the chassis mating with the VFO and mixer chassis. A note was made of the cables through each of the two grommets. Particular care was taken to note the position of

the two 435kHz crystals, as one is a series resonant type, and the other specified for operation with 30pF parallel capacity. A sketch was made of the wires that had to be unsoldered from the Net/Carrier Insertion potentiometer, and the screened cable to a tag strip on the underside.

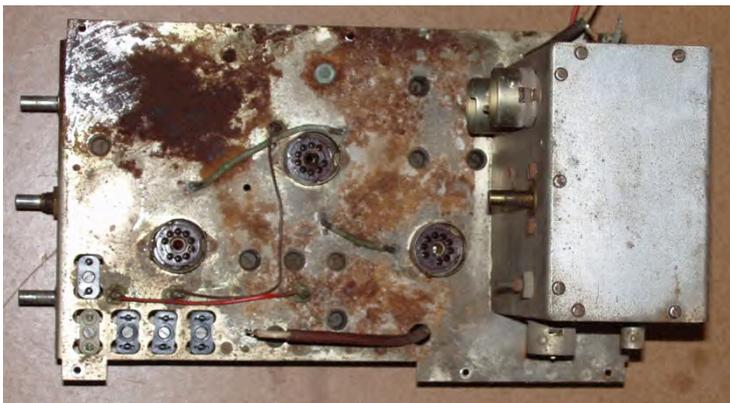
*Figure 6. The VFO (upright box at right) and mixer chassis. This was the worst affected unit, especially top left.*

As with the sideband generator chassis, a sketch was made of the layout at the outset. The flexible coupler to the main tuning capacitor was removed. While a note of the dial setting (3.9MHz) was made, the setting of the VFO tuning was inevitably moved during cleaning. A coax cable with its inner only connected to a feed-through on the side of the PA compartment was disconnected. The three self-tap screws connecting to the PA chassis were removed, one proved difficult and was left to soak with WD40. The wires to the PA chassis were unsoldered; the arrangement in the 'power distribution' screened compartment with the power supply connector was noted with care as several wires of the same colour passed through. The Jones power supply plug was then detached as wires from it went through a grommet to the PA.

close to the panel, then a row of FT243 types, from the panel: 6000, 6250, 8025 and 8175kHz. All were cleaned in an ultrasonic bath. The chassis was cleaned, then painted using the procedure described above.

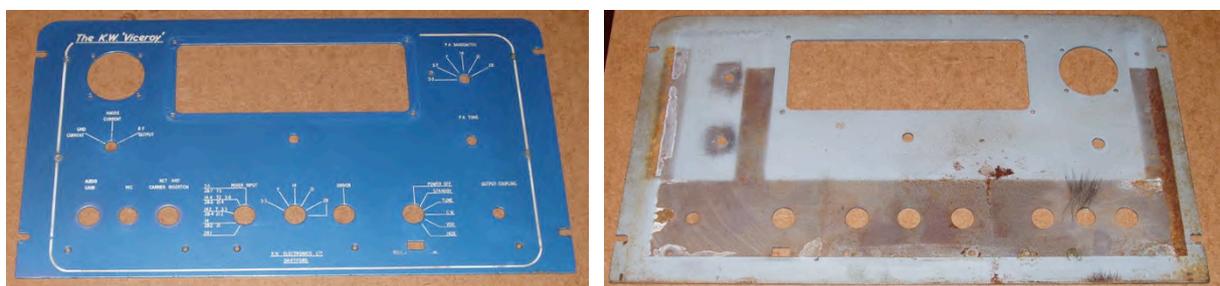
Figure 8. Left: the front panel and, right, the rear of the front panel before cleaning.

Rust stains on the rear of the front panel were removed first with emery paper on a small electric sander, followed by rust converter, and spray painted with a grey primer, Figure 8. All this was done with the front face resting on a flat surface on a sacrificial protective cloth. The front panel was cleaned with a kitchen cleaning product.

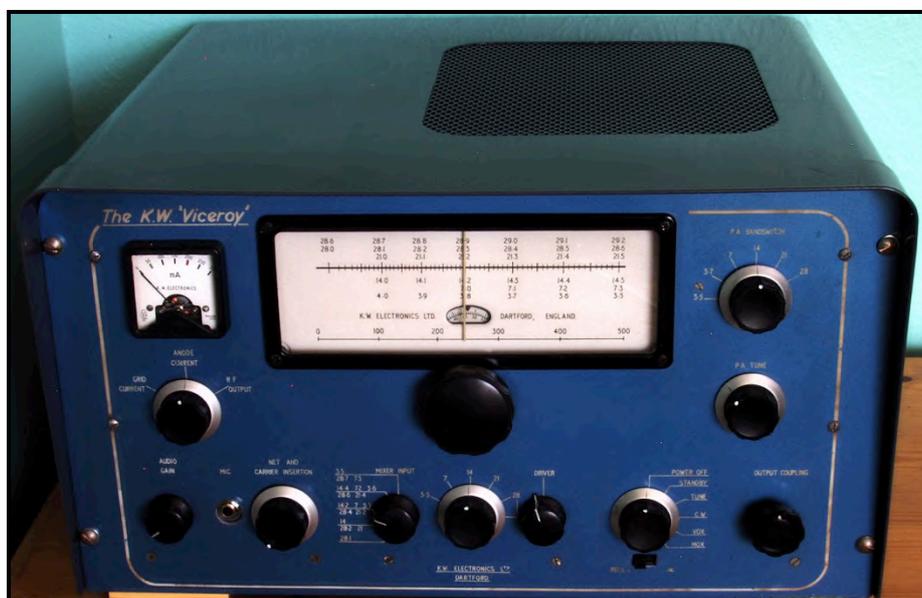
Figure 11. The restored Viceroy Mk IV with the original front panel and its powder-coated case.

The wrap-around case was not too badly rusted; mild corrosion was limited to a few areas. The finish was a smooth grey, not a hammer tone finish. Given previous good experience from powder-coating specialists A1 Powder Coating at Woolston, Southampton, the case was taken to them for painting, in a colour very close to the original, Figure 11.

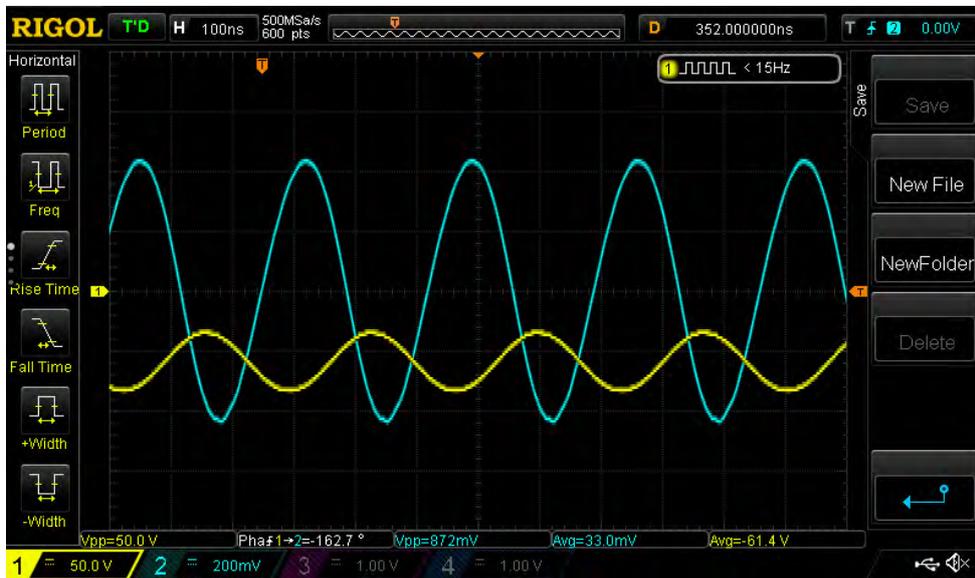
Figure 12 80 metres PA grid voltage DC coupled in yellow and driver grid voltage AC coupled in blue. Why was there grid current being drawn when the PA grid voltage was nowhere near zero?

sure that the dual-gang 15pF "Driver" tuning was tracking, I could get 200V peak to peak at the 50 ohm dummy load on MOX on 80 metres. However, the output for each of the higher bands dropped away to nothing on 10. Then came

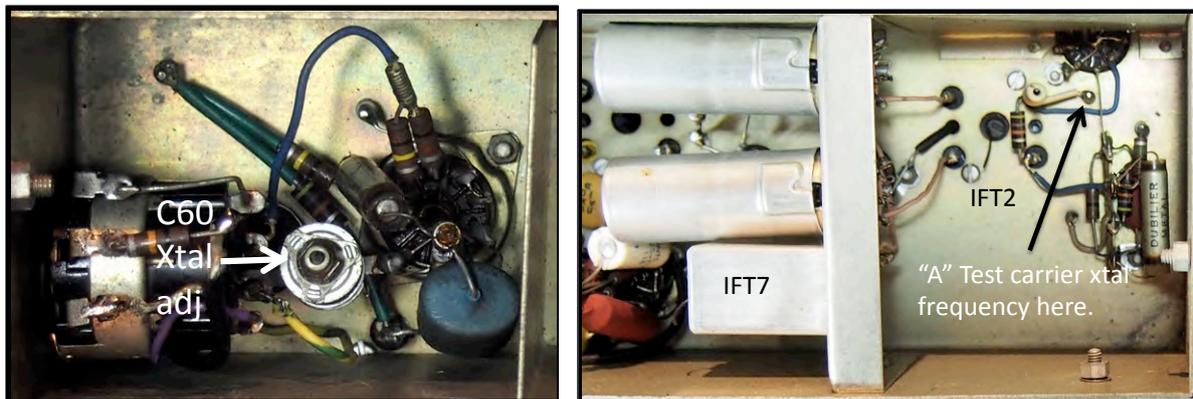
The 435kHz "carrier" crystal oscillator at the feed-through point "A" in Figure 16 (Right) was 35mV rms with the Carrier Insertion control fully CW. The frequency was 435.006kHz; no alternation was made to the carrier Phillips beehive trimmer C60, Figure 16 (Left).

Figure 16 Component layout for (Left) 435kHz crystal oscillator. (Right) part of the crystal filter and part of the 435kHz IF amplifier top right with carrier test point, with Carrier Insertion control fully CW.

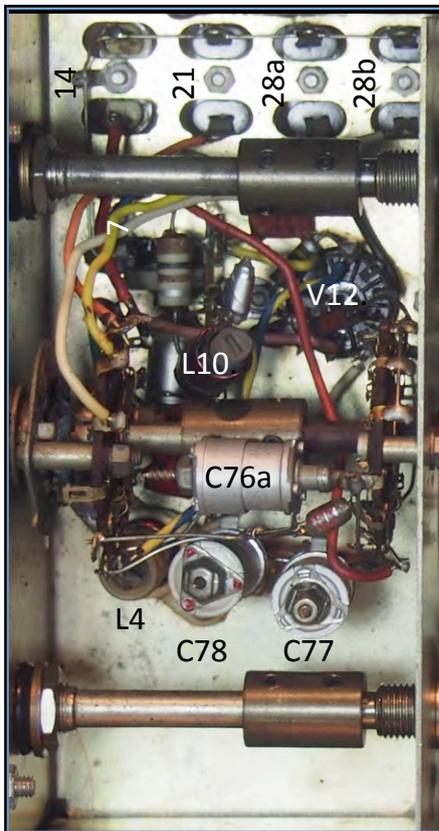
Figure 24 Component layout of the crystal oscillator for the second mixer.

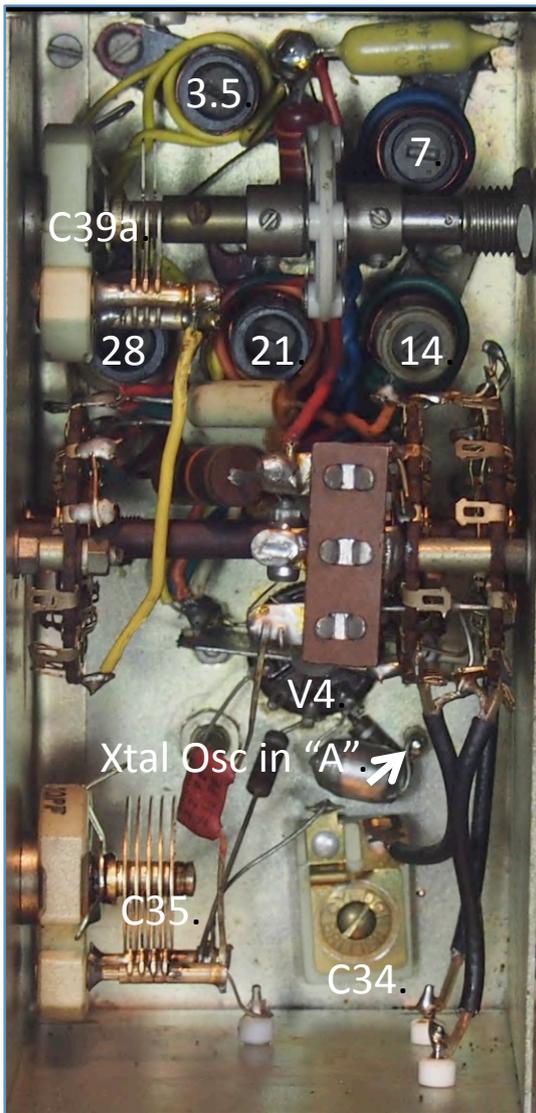
Figure 26 Component layout of the second mixer sub-chassis.

The manual states that the initial adjustment is that of L4 for maximum output (on a valve voltmeter) at V4 cathode (test point "A" in Figure 26) on the 28MHz band-switch setting. There is no mention in the handbook of how to adjust L11. In practice aligning this stage was the most difficult, it is quite possible to tune the outputs to the wrong harmonics. This was especially true for the lower frequency 28MHz band (8025kHz crystal). The wanted 32100kHz output was difficult to achieve, the highest amplitude output was at 16050kHz, then 24075kHz; there was minimal output at 32100kHz, even after L10 was adjusted, and different combinations of L4 and L10 tuning tried. The waveform at Figure 25a (left) was the best that could be achieved; the 32100kHz component is about 0.5V rms. It is not surprising that the drive on 28MHz is down compared with the other bands.
